GLAST Monthly PSR

Safety and Mission Assurance

January 2004

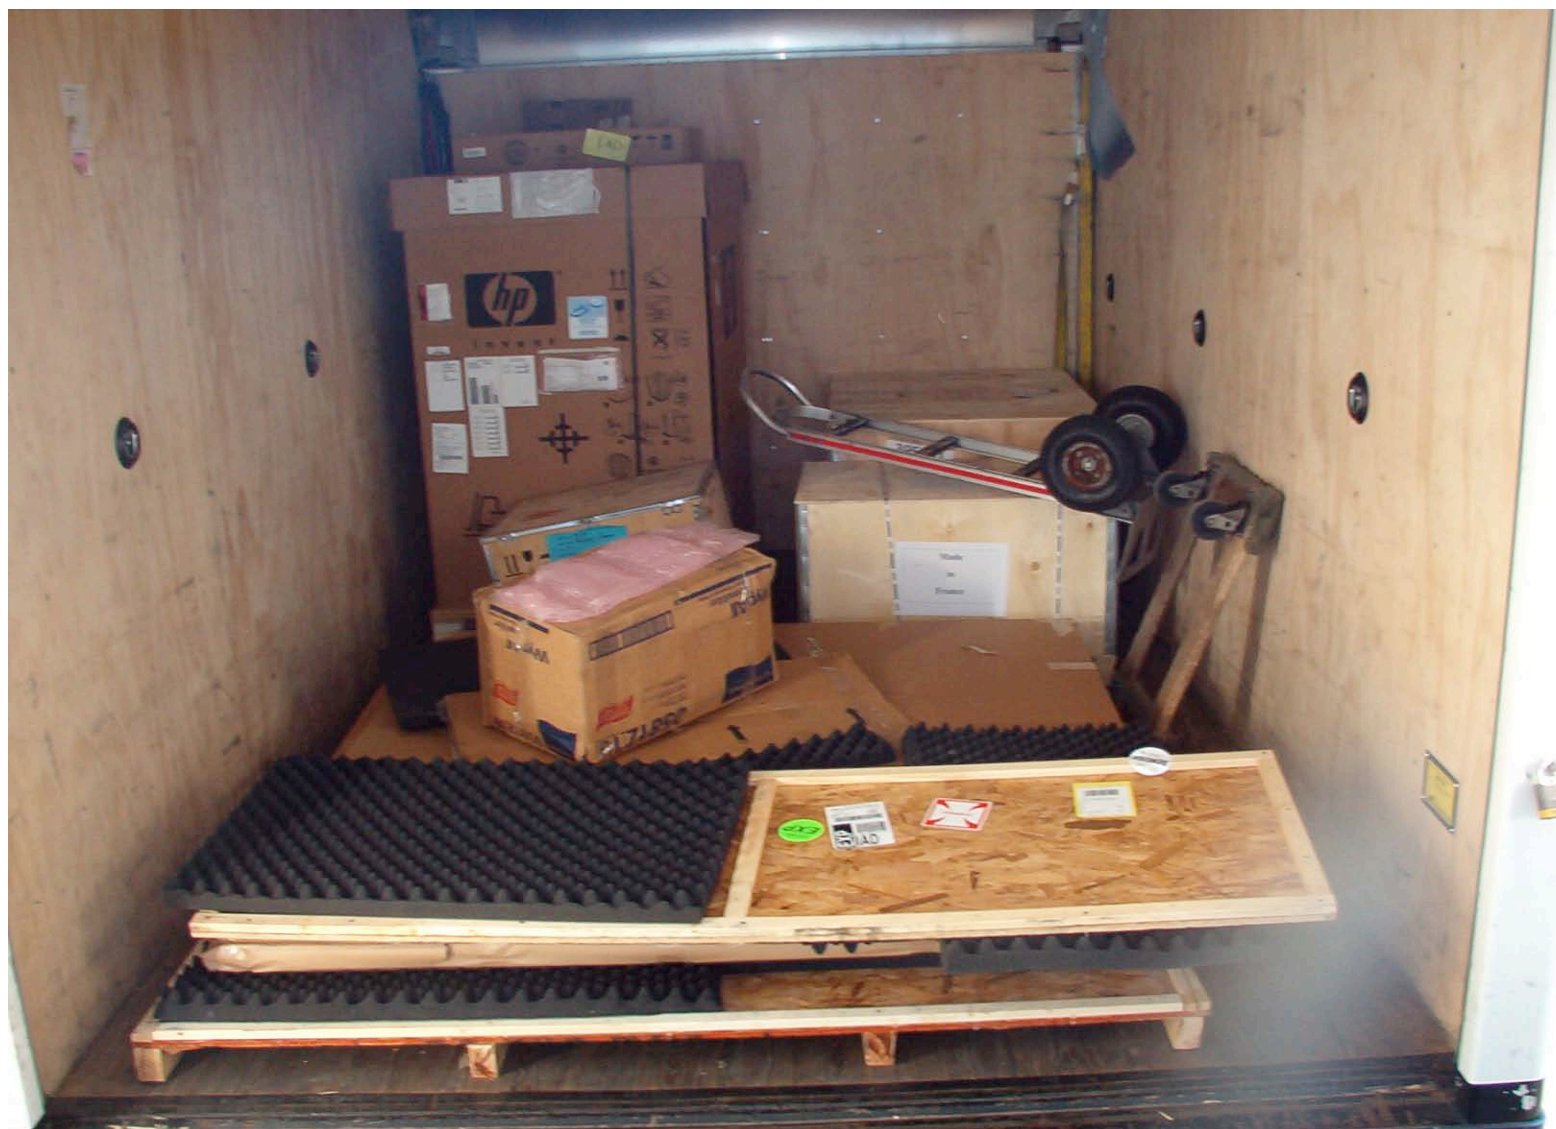
- The ACD QE attended an ACD TSA (Tile Shell Assembly) fit check and source inspection on Dec 15th through 17th at Canyon Composites. The fit check and source inspection activities were considered successful and requirements for shipment were met.
- 5 side panels were delivered to GSFC on 12/23 from Canyon. An incoming inspection was performed on all panels. Results of the findings were documented on a Problem Report for serial numbers 001,002,003 and 004 side panels. Some of the defects included delaminated tabs, face sheet chipped, un-repaired ply damage and Core not trimmed. These were a result of poor preparation of the panels prior to shipment to GSFC, but most of the defects can be repaired and are not show stoppers.
- Top and spare panels were received at GSFC on Tuesday January 5th. These parts arrived damaged. ACD composite engineers are evaluating the degree of damage.
